# RENLITA DOORS NORTH AMERICA LLC THERMAL PERFORMANCE TEST REPORT

S-500 / S-1000 / S-2000 / S-3000 GARAGE DOORS

L0326.01-116-46 R0

Intertek Building & Construction (Intertek B&C) was contracted by Renlita Doors North America LLC to evaluate the thermal performance per NFRC 102-2017. The purpose of this testing was to evaluate the U-Factor performance. Results obtained are tested values and were secured by using the designated test method. Testing was conducted at Intertek B&C test facility in York, Pennsylvania. This report does not constitute certification of this product nor an opinion or endorsement by this laboratory.

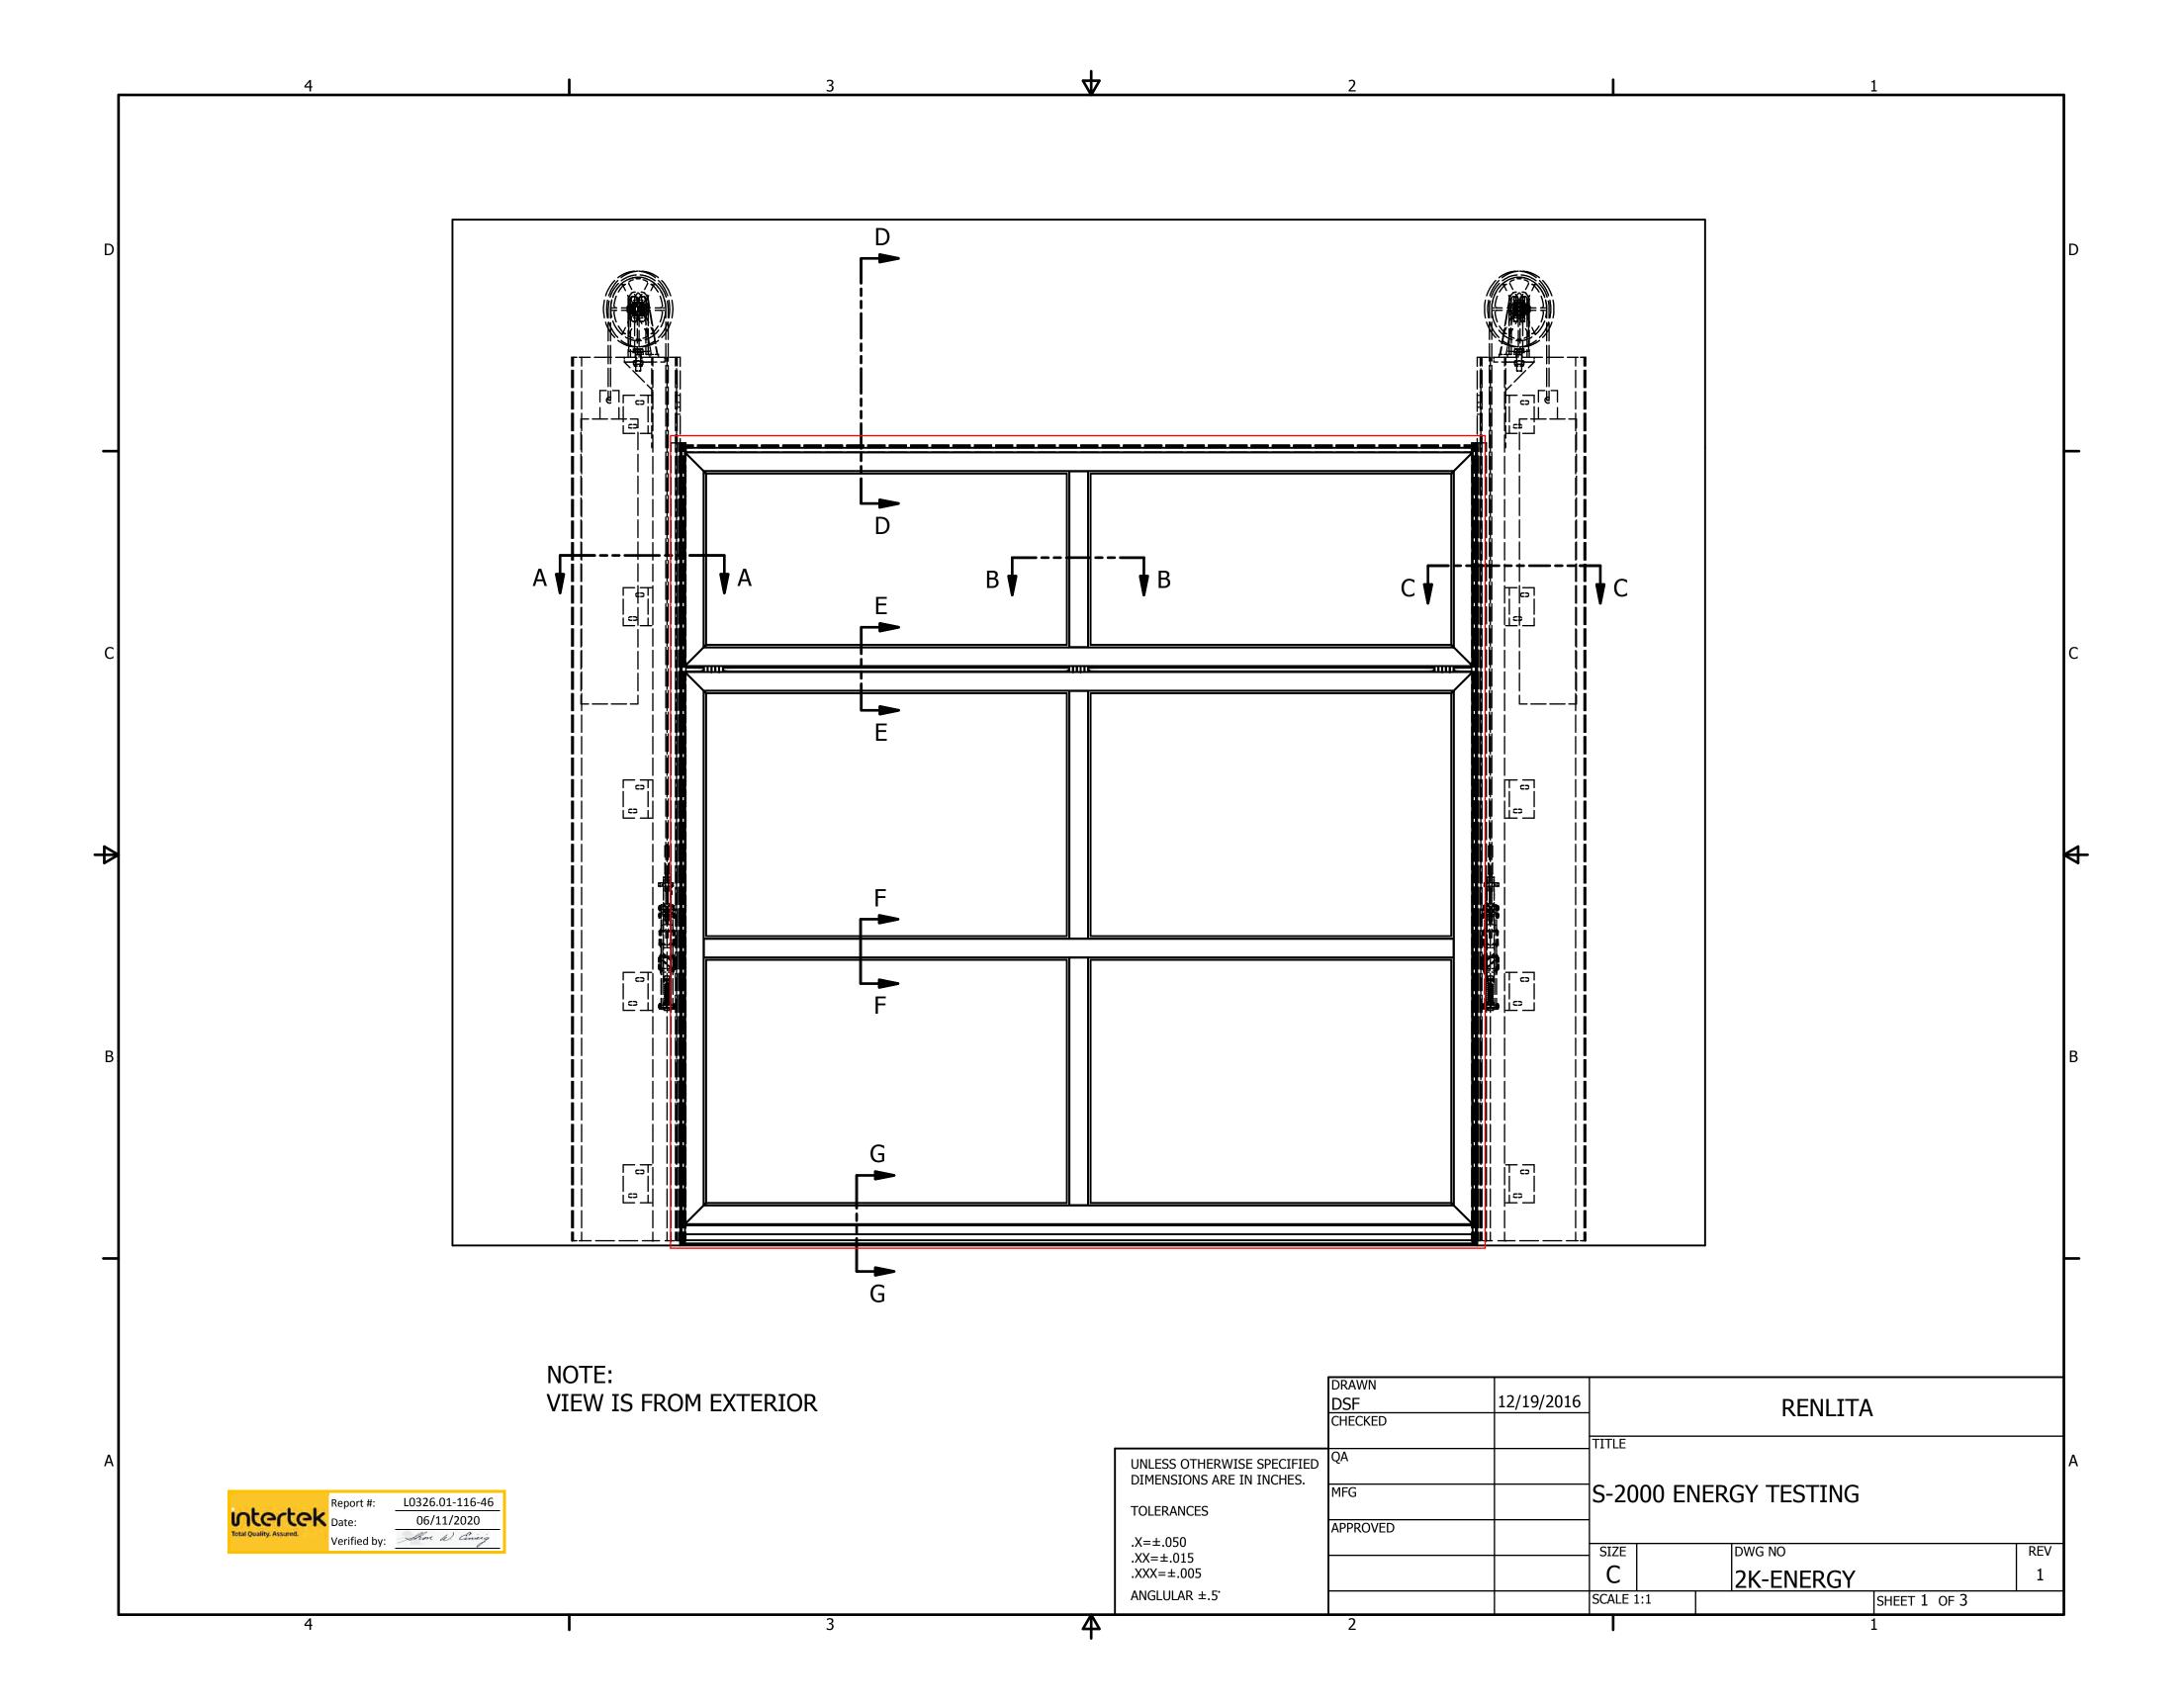
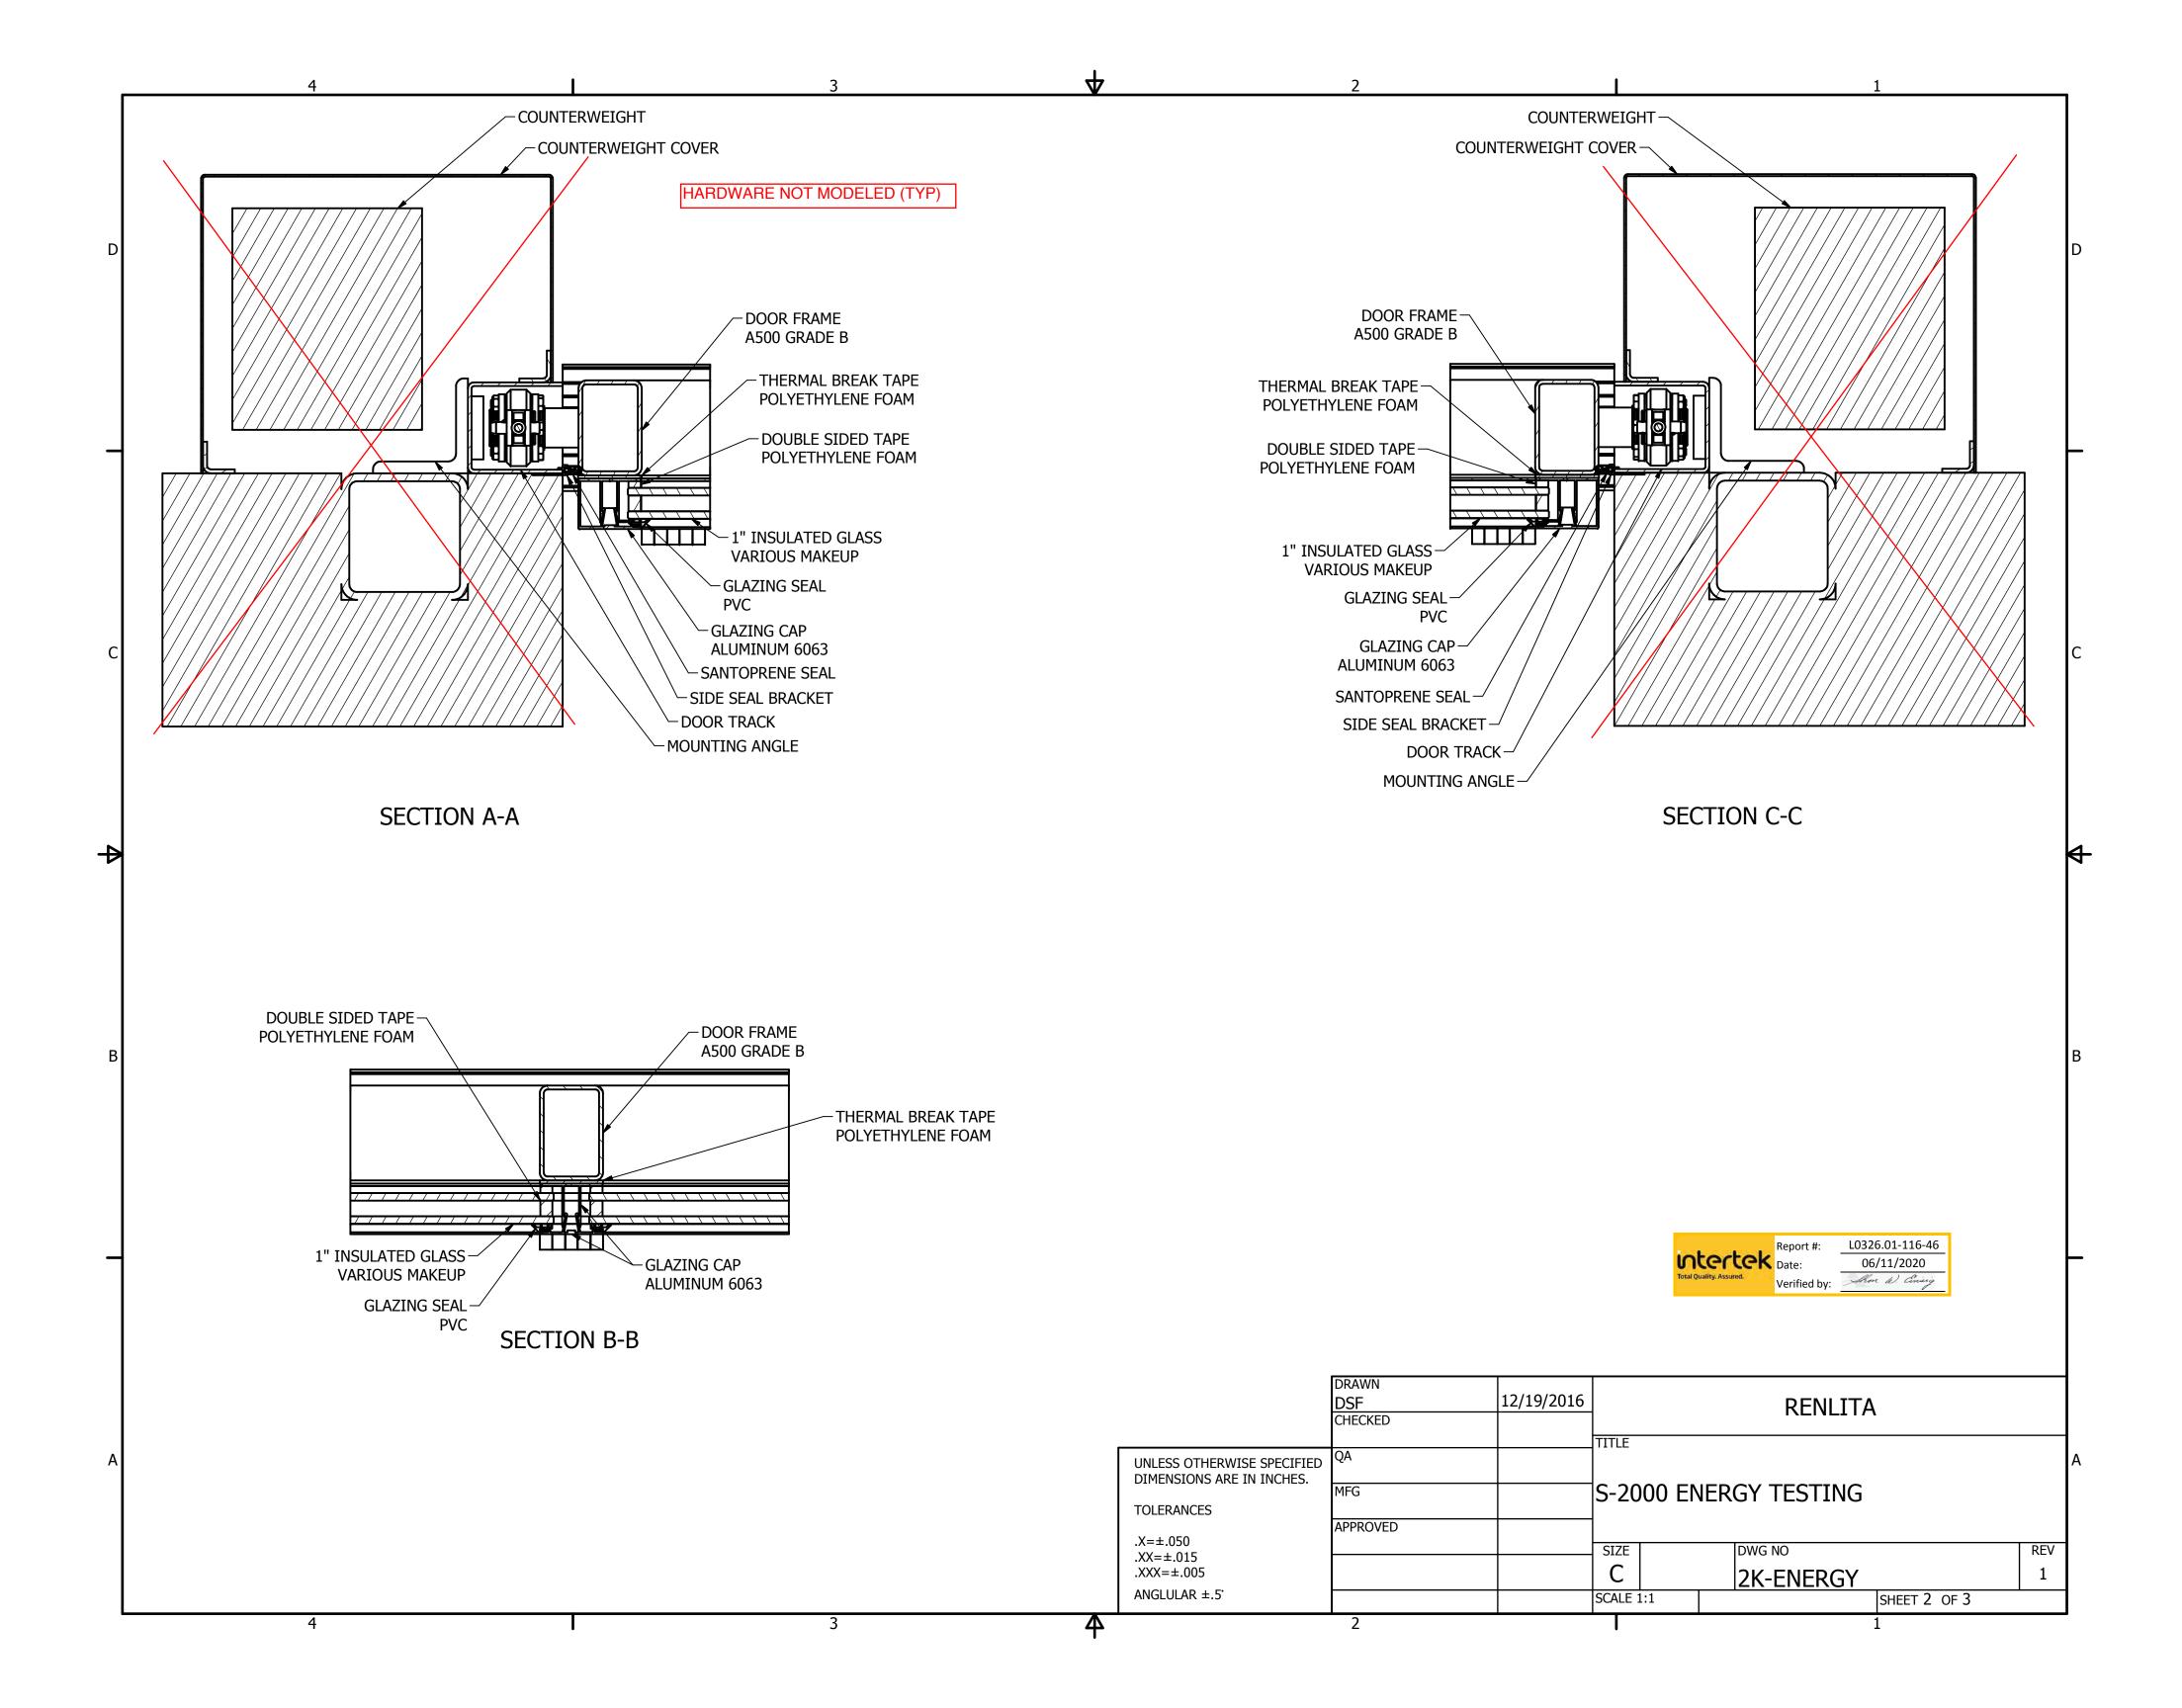
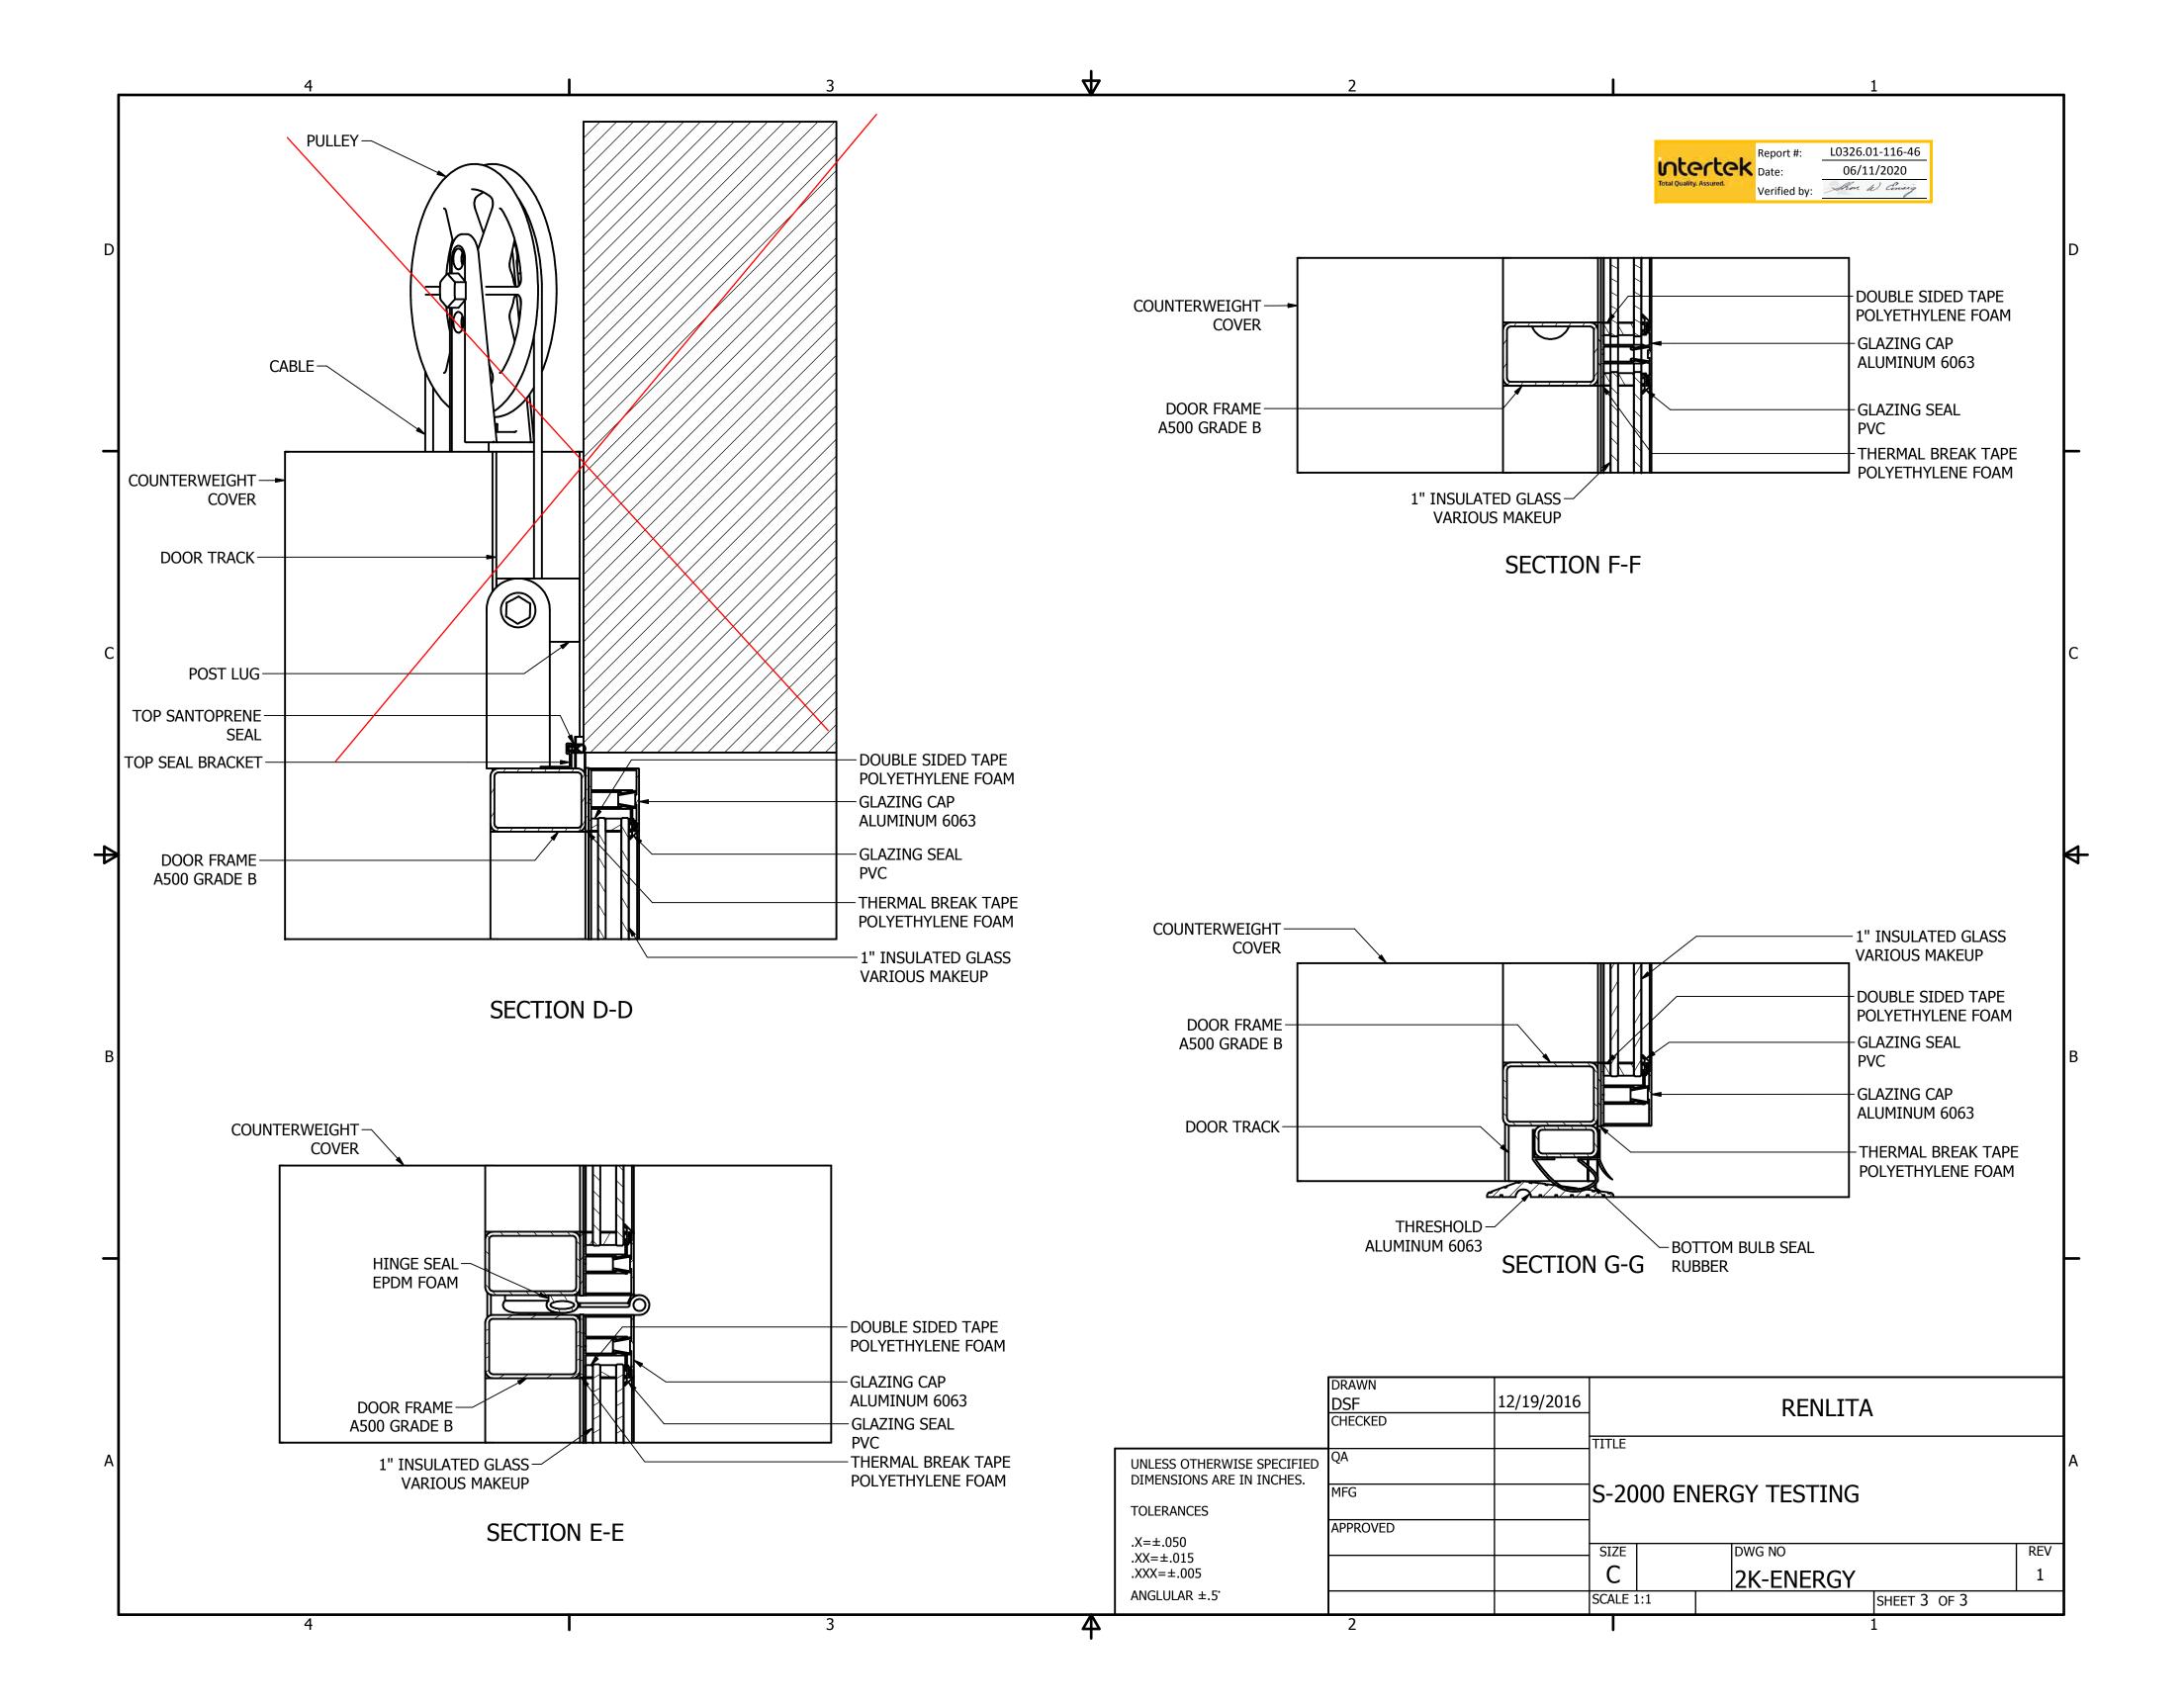
#### **SUBMITTAL FORM AND DRAWINGS**

The test specimen drawings which follow have been reviewed by Intertek B&C and are representative of the test specimen(s) reported herein. Test specimen construction was verified by Intertek B&C per the drawings included in this report. Any deviations are documented herein or on the drawings.

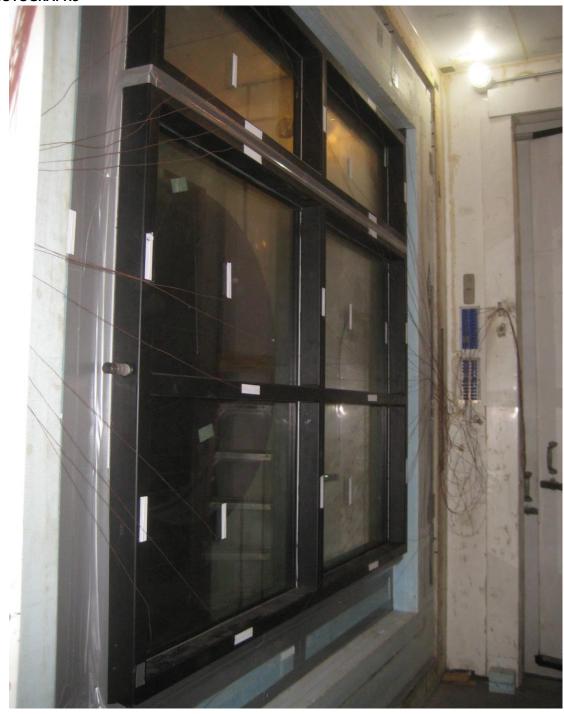
PHOTOGRAPH 1 - Interior of garage door installed

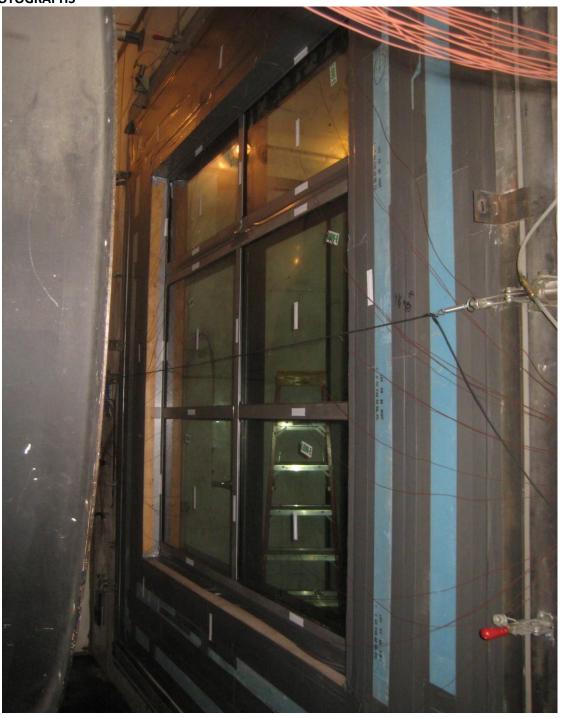
PHOTOGRAPH 2 - Exterior of garage door installed

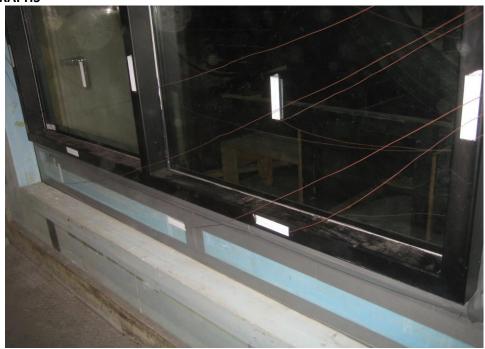
PHOTOGRAPH 3 - Interior bottom of garage door installed

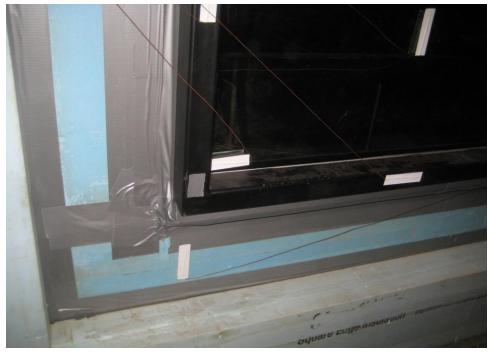
PHOTOGRAPH 4 - Interior bottom left of garage door installed

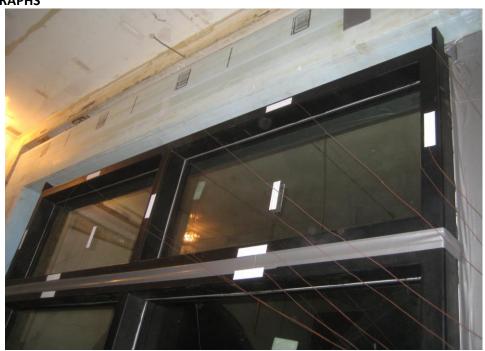
PHOTOGRAPH 5 - Interior top of garage door installed

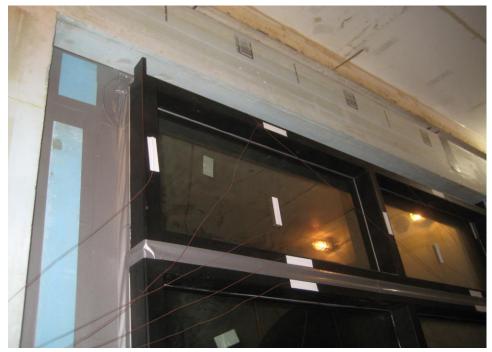
PHOTOGRAPH 6 - Interior top left of garage door installed

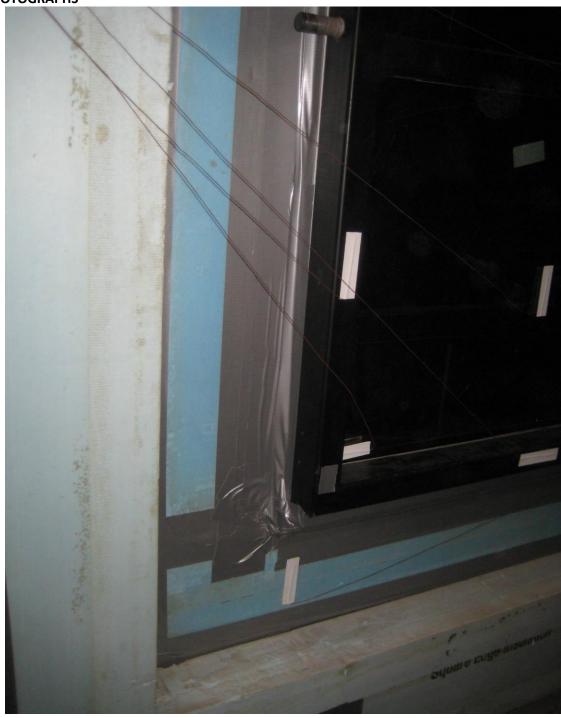
**PHOTOGRAPH 7** - Interior bottom left of garage door installed

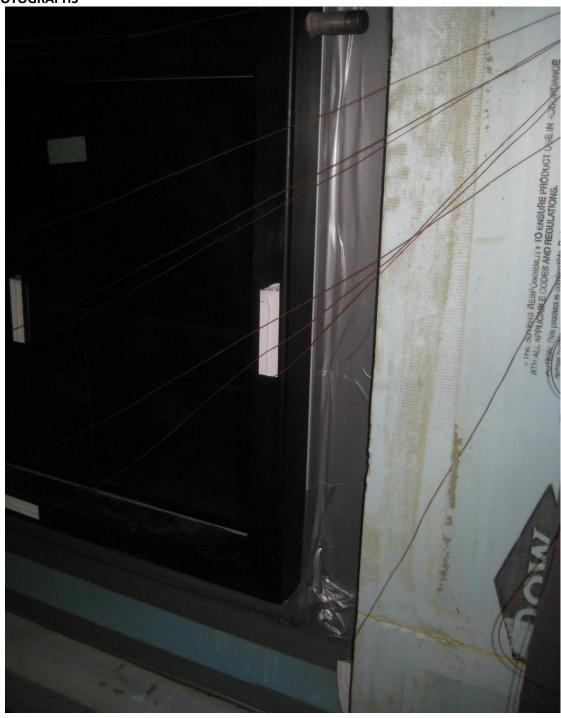
PHOTOGRAPH 8 - Interior bottom right of garage door installed

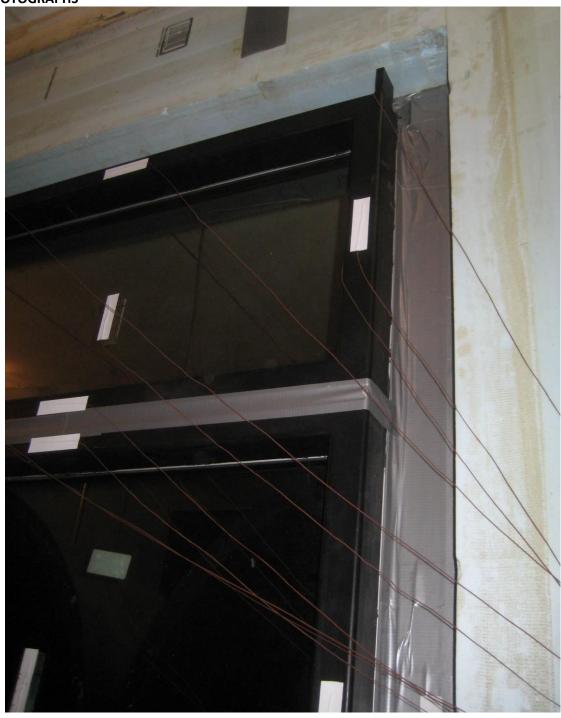
PHOTOGRAPH 9 - Interior top right of garage door installed
